J.R. Simplot Company
Simplot Headquarters
1099 W. Front Street
Boise, Idaho 83702
P.O. Box 27
Boise, Idaho 83707

July 8, 2019

EXECUTIVE SUMMARY

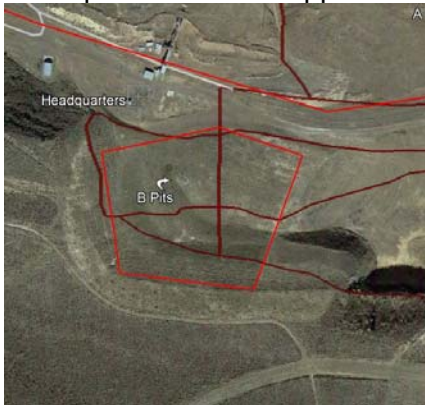
Headquarters Area – Approximately 2,600 feet

Fencing is on Overburden

Below are the proposed areas for fence removal. Over 6,800 feet of fencing is identified. One area in the East Limb has not been positively identified or estimated. The company's request that the tribes mark the fencing that is to be removed with pink flagging to confirm that we are removing the correct fencing. All fencing materials will be removed from the site and disposed of. The companies will contract with Kase Warbonnet for the fencing removal.

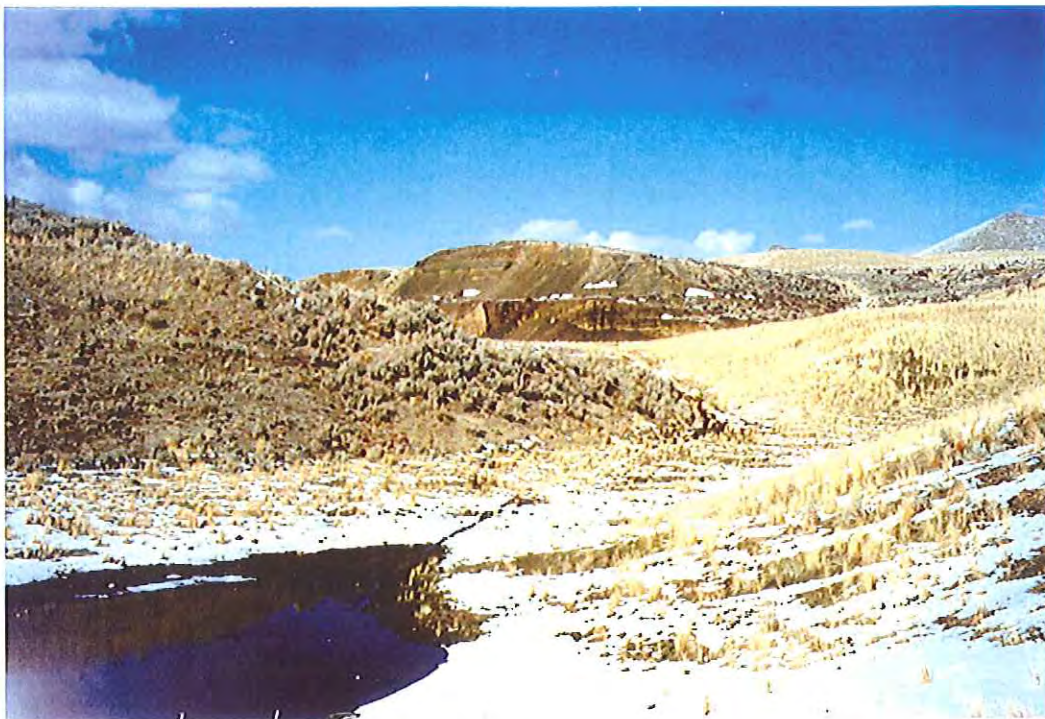
Photograph No. 3.2-1
O Pond looking to P Pit
3/2/00

The O Pit has been reclaimed and has a small pond that is accessed by livestock. The pond is in a low lying area where stormwater appears to accumulate. Pond volume appears to seasonally fluctuate. It has not been determined whether this pond water has elevated selenium concentrations. If future sampling defines a problem, then the pond can be easily filled from the surrounding material. The general observation is that the water in the pond is on reclaimed material and is not in contact with the selenium bearing material. If this pond has selenium below regulatory aquatic standards, then it should be left as a water source for livestock and wildlife.

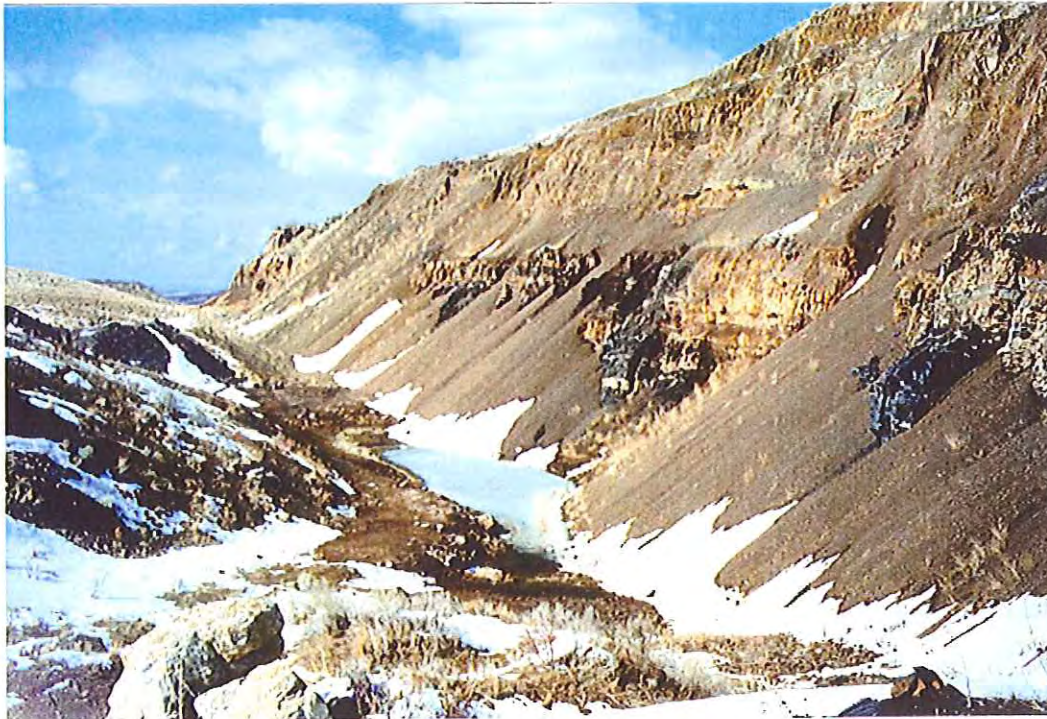
Photograph No. 3.2-3
P Pit and pond
3/2/00

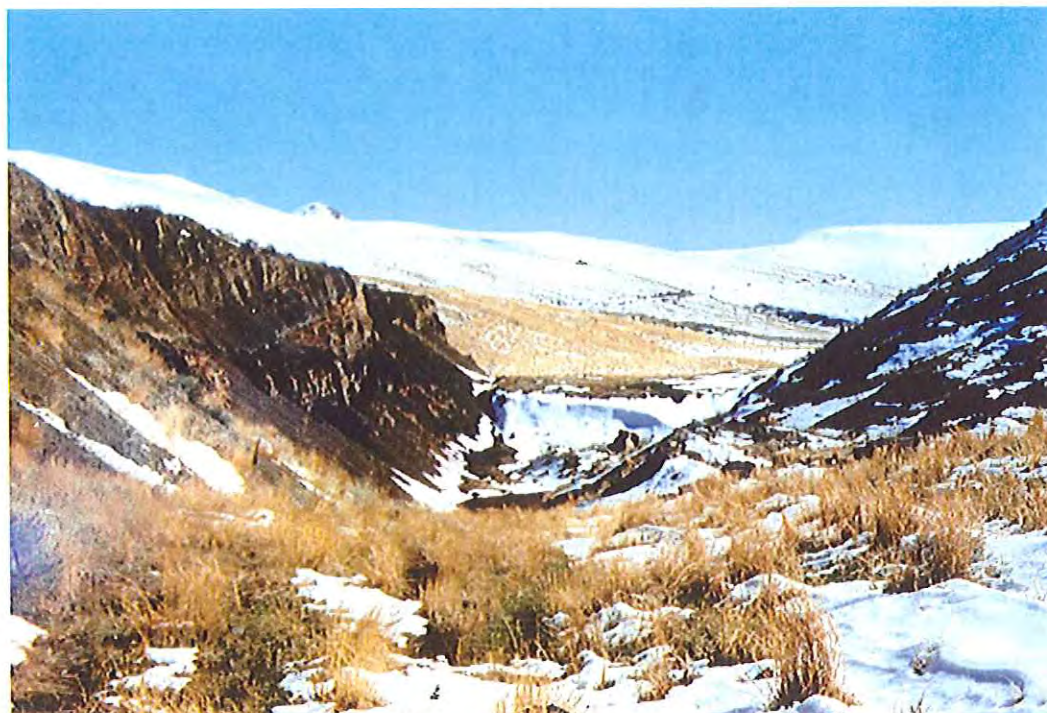
Photograph No. 3.2-4
P Pit from NW end
3/2/00

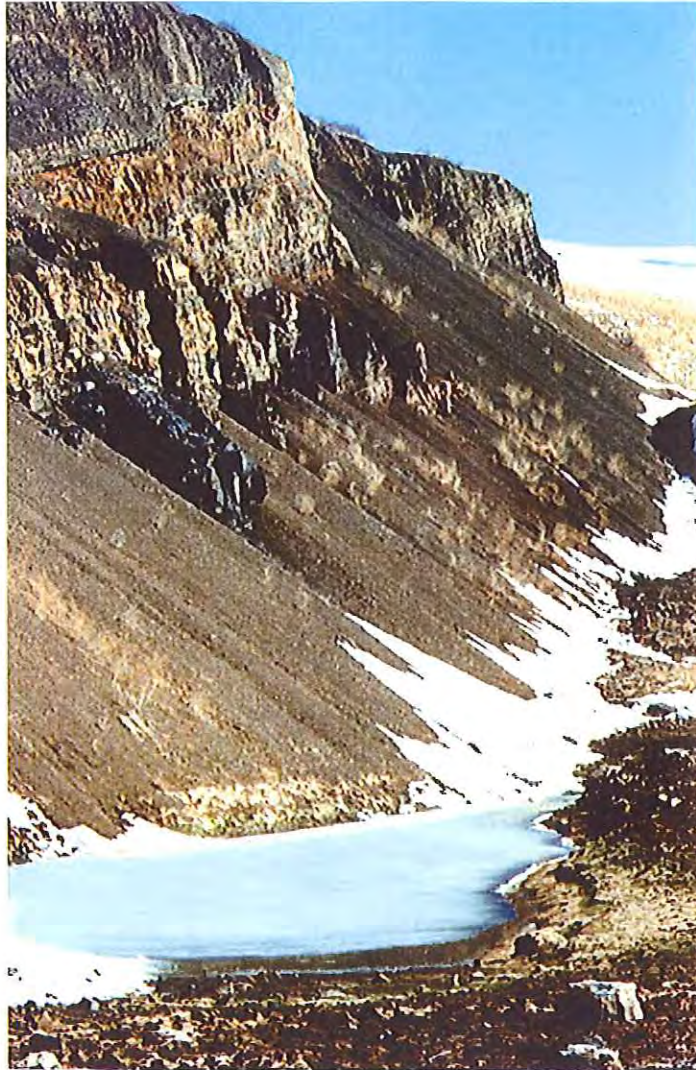
Photograph No. 3.2-5
P Pit NE wall
3/2/00

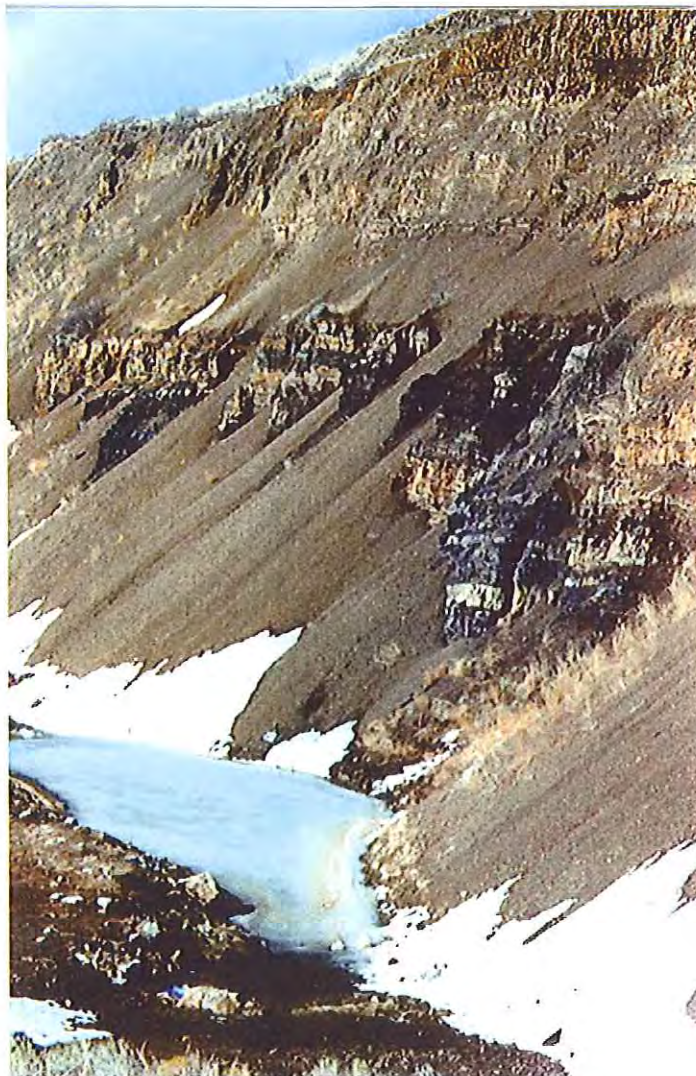
Photograph No. 3.2-6
P Pit NE wall from SE end
3/2/00

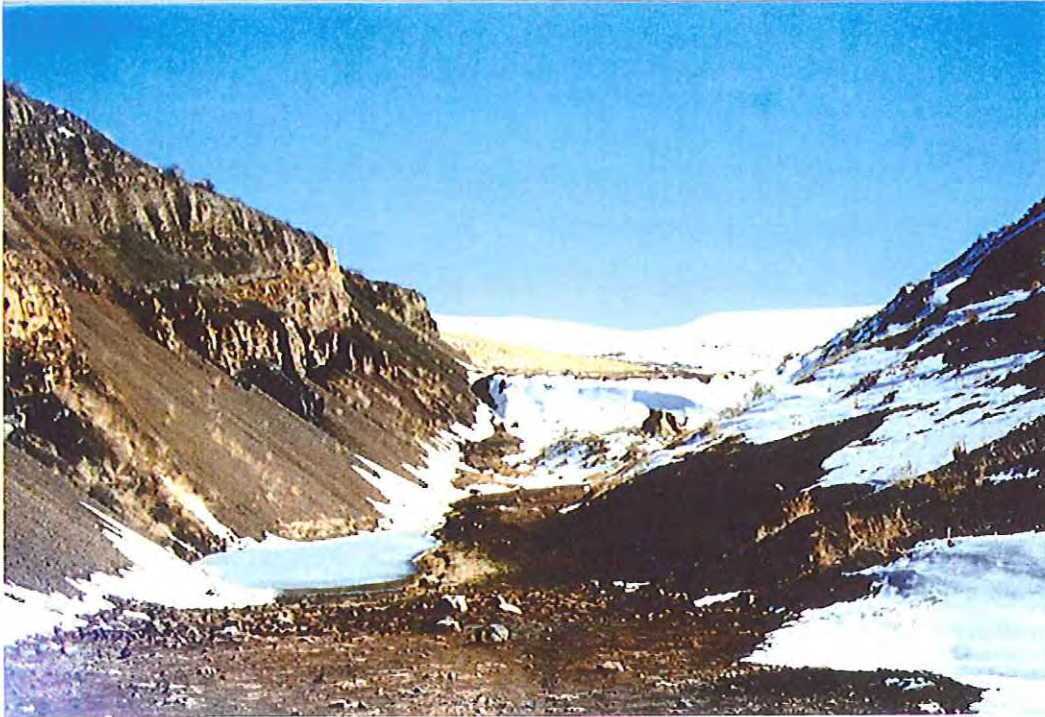
Photograph No. 3.2-7
P-Pit looking from NW end looking SE
3/2/00

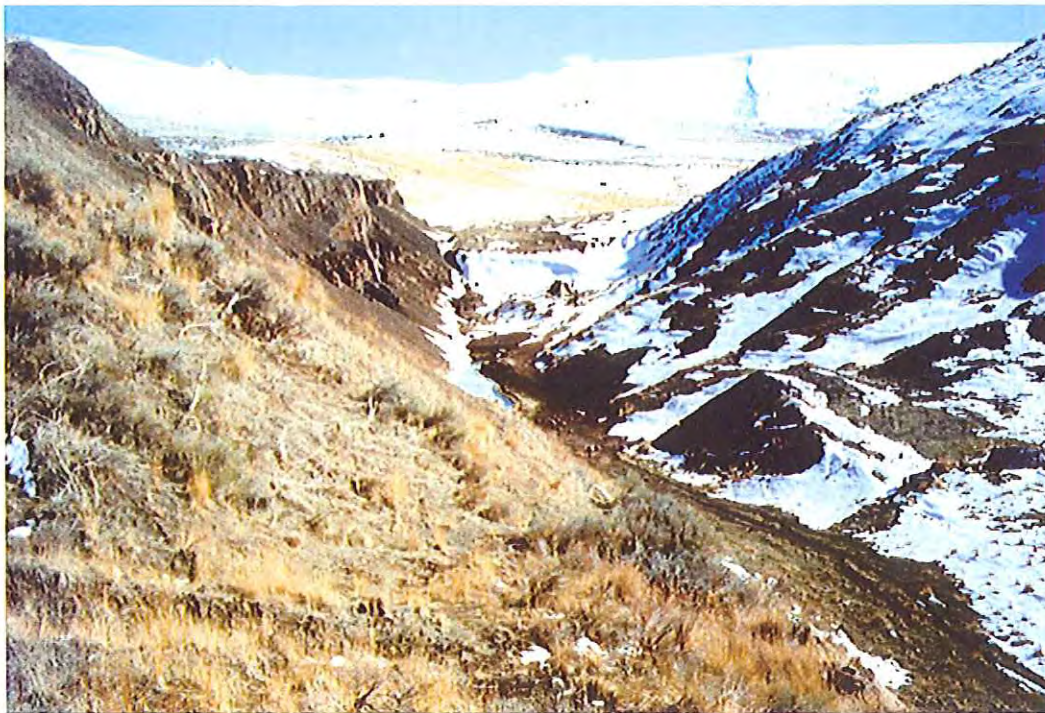
Photograph No. 3.2-8
P Pit from above
3/2/00

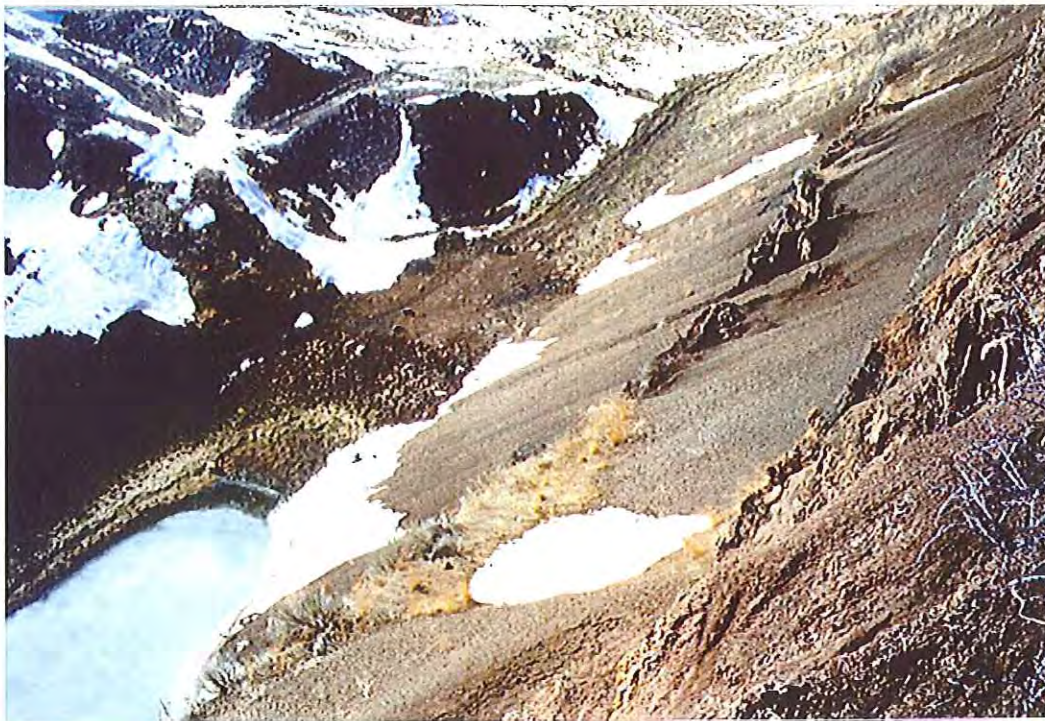
Photograph No. 3.2-9
P Pit SE end from above
3/2/00

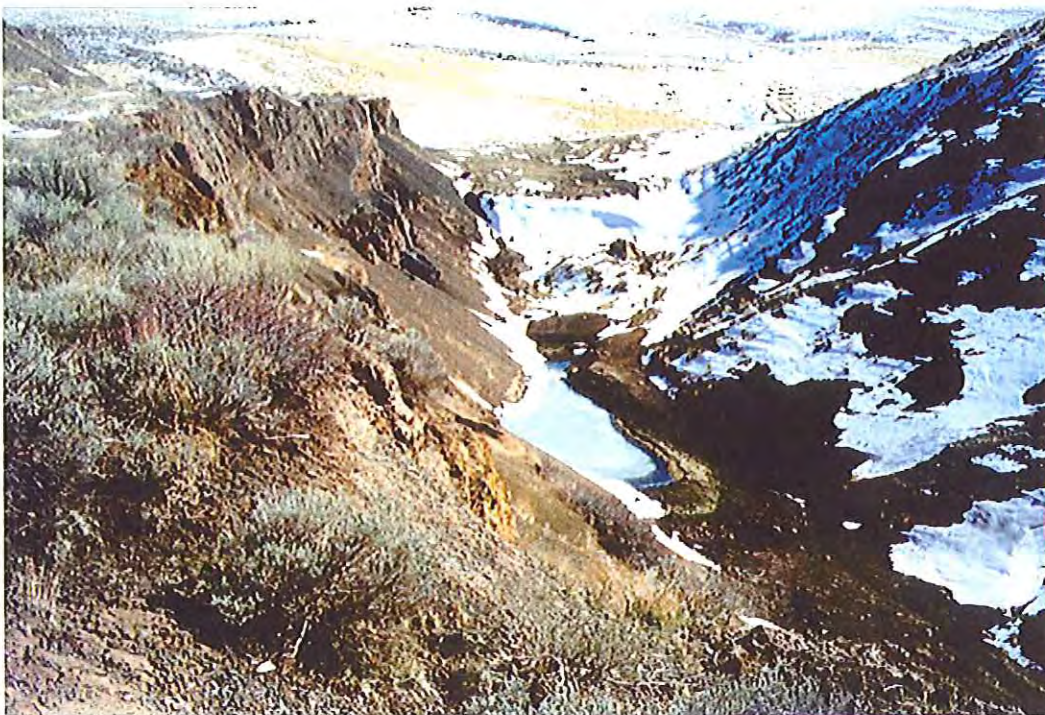
Photograph No. 3.2-10
P Pit from above
3/2/00

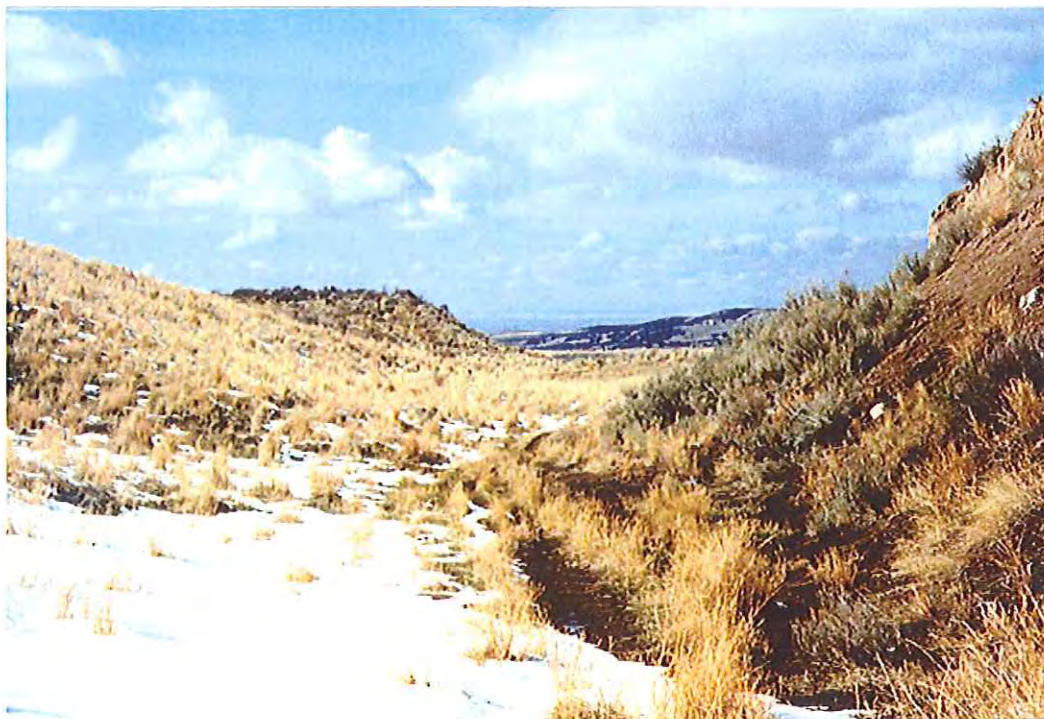
Photograph No. 3.2-11
P Pit looking NW as potential drainage area
3/2/00

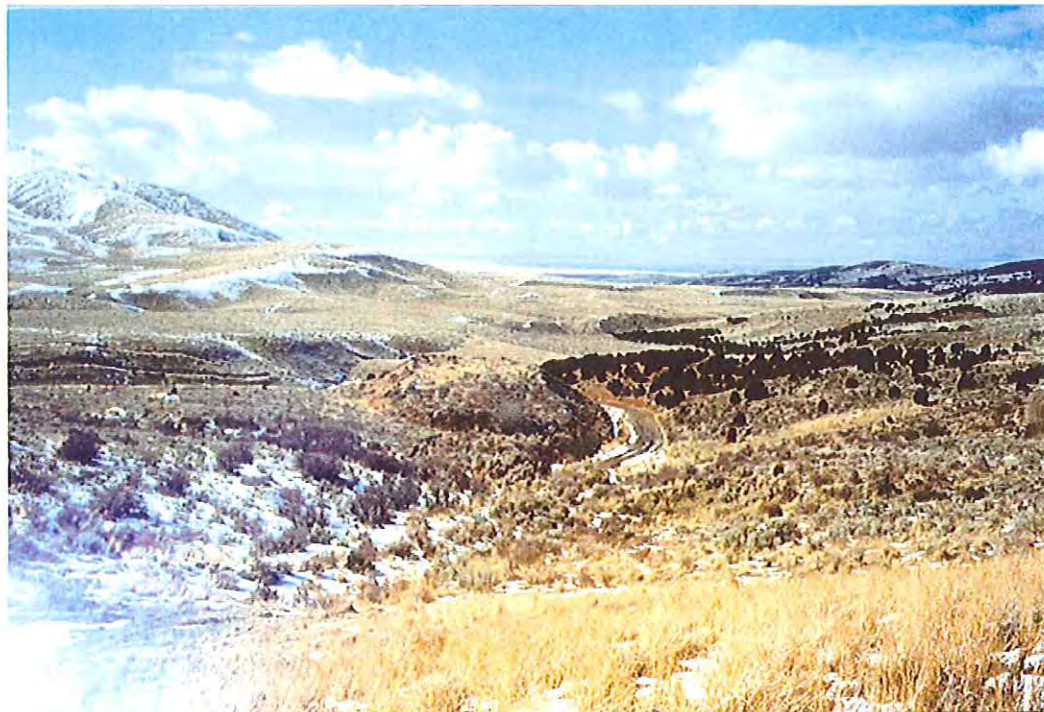
Photograph No. 3.2-12
Lincoln Road from NW end of P Pit
3/2/00

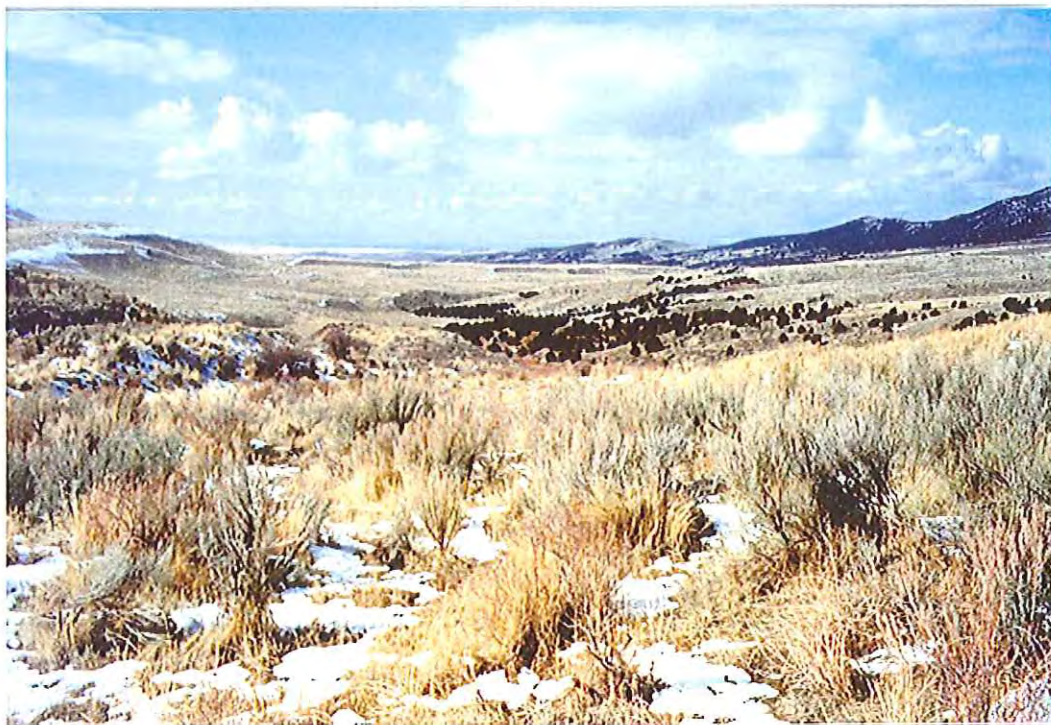
Photograph No. 3.2-13
NW to Blackfoot potential drainage from P Pit
3/2/00

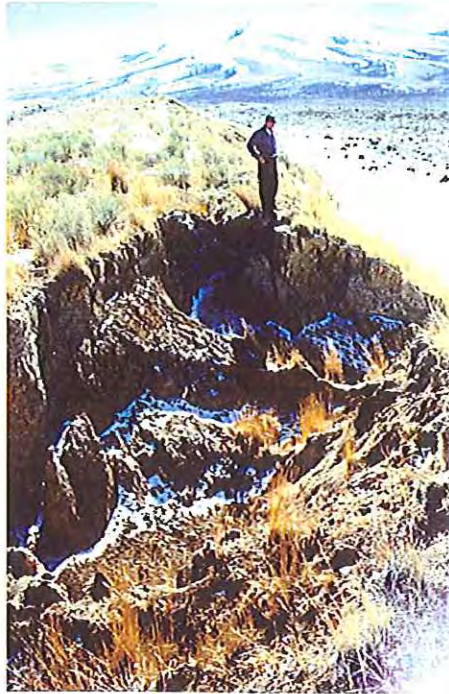
Photograph No. 3.4-3
SW side of J culverts fix or use for fill
3/2/00

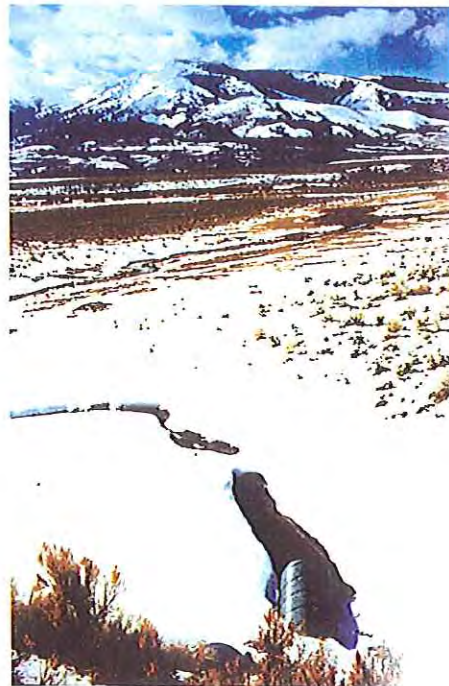
Photograph No. 3.4-4
SW side of J culverts
3/2/00

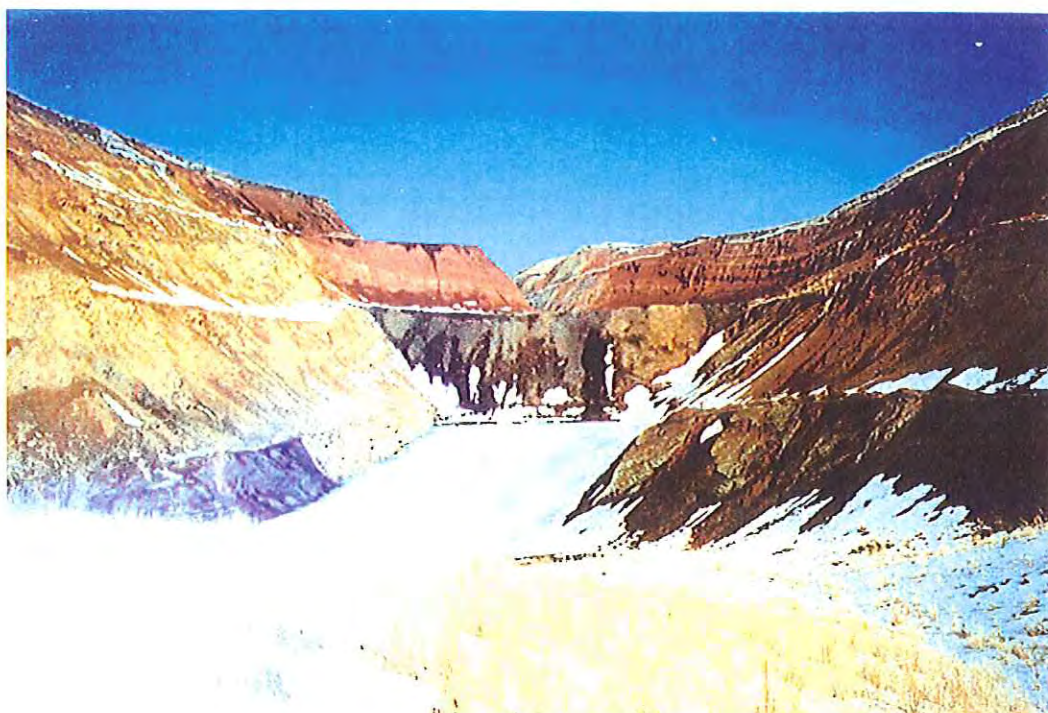
Photograph No. 3.4-6
JF Pit Pond
3/2/00

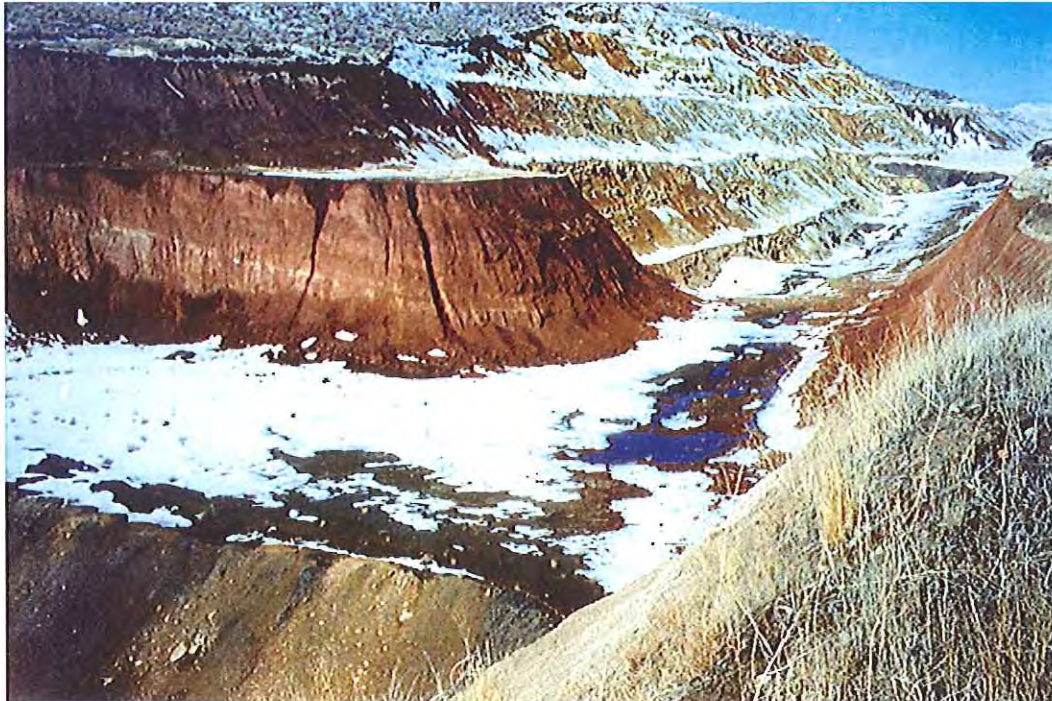
Photograph No. 3.4-8
Barren Material "Plug" JF Pit
3/2/00

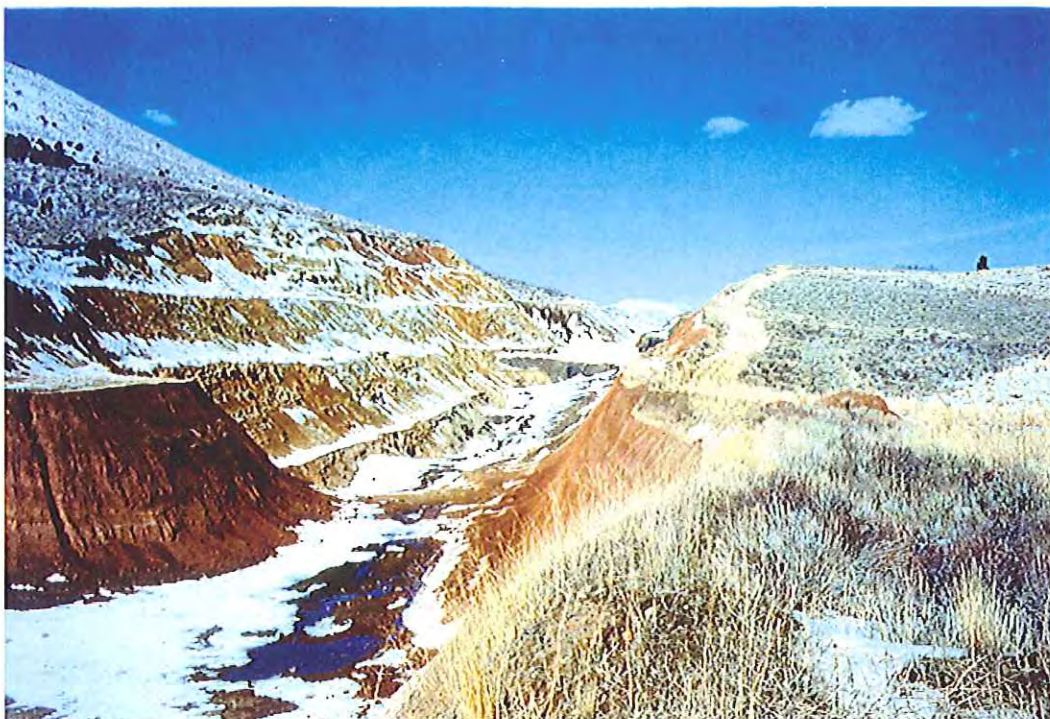
Photograph No. 3.4-9
NW looking up along J Pit
3/2/00

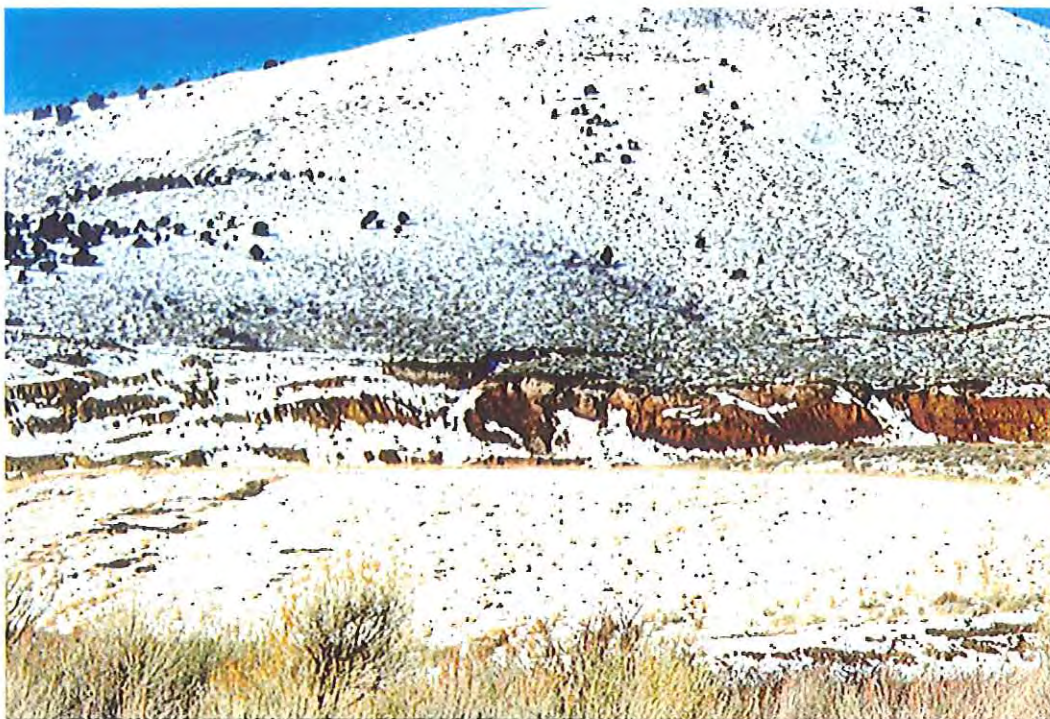
Photograph No. 3.4-12
West side of J Pits
3/2/00

Raymond). This discussion suggested that the material in the east highwall is not consolidated enough for cast blasting. Excavation of material from the west highwall would likely result in slope failure (Photos 3.4-12 through 3.4-14). The east highwall has some loose material on the top and at the toe of the slope within the pit. Cast blasting is not effective when the material is loose or there is loose material at the toe of the slope. The cast blasting option may be effective if the loose material is removed from the top and toe. The merits of this option requires an evaluation by a blasting contractor. The work sequence for this option is:

- Push the fill from the north end of the pit to the west side of the pond.
- Push the loose material from the east side and toe of the slope off the solid rock in the east highwall.
- Cast blast the east highwall into the pit.
- Dress all areas with dozers.
- Reclaim the fill, blast and borrow areas.

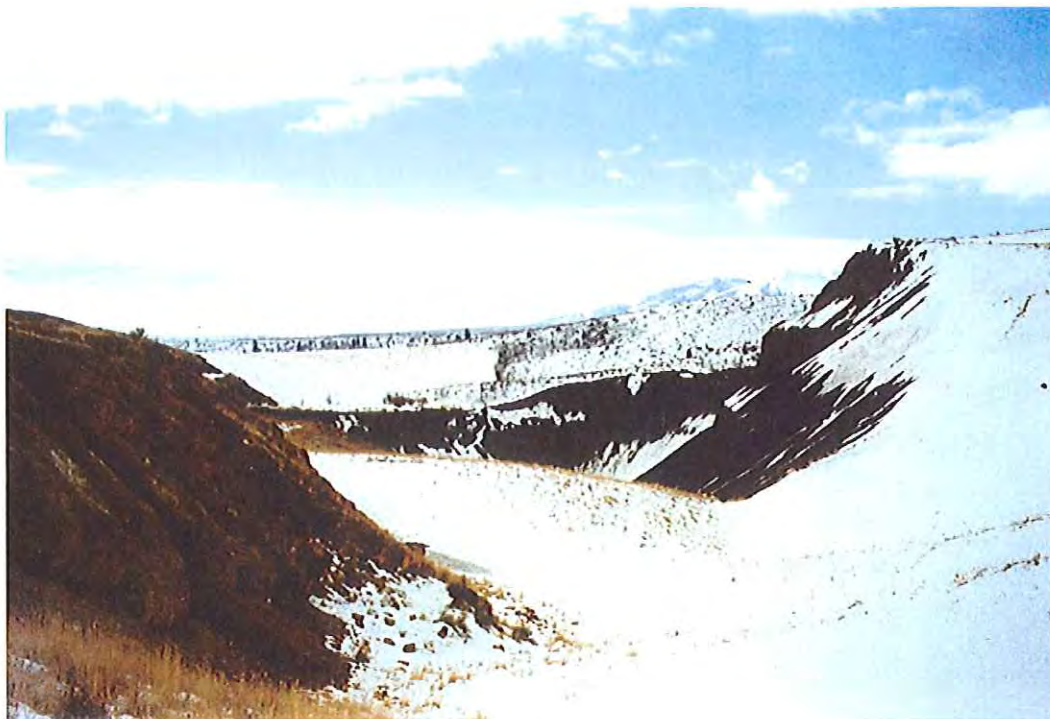
Photograph No. 3.5-1
Z Pit from north extension
3/2/00

presented in Photos 3.5-1 through 3.5-10 and Drawing Z. The pit bottom is mostly covered with water and the sides of the pit are a combination of rock highwalls and fill material. The west side has a large fill area that is dumped at the angle of repose (Photo 3.5-2) with exposed seams (Photo 3.5-8). The circumference of the pond is approximately 1,021 feet and the top of the seam on the west side is 45 feet above the water level. On the east side, the seam is covered by fill material, but the seam is probably 10 feet above the water level.

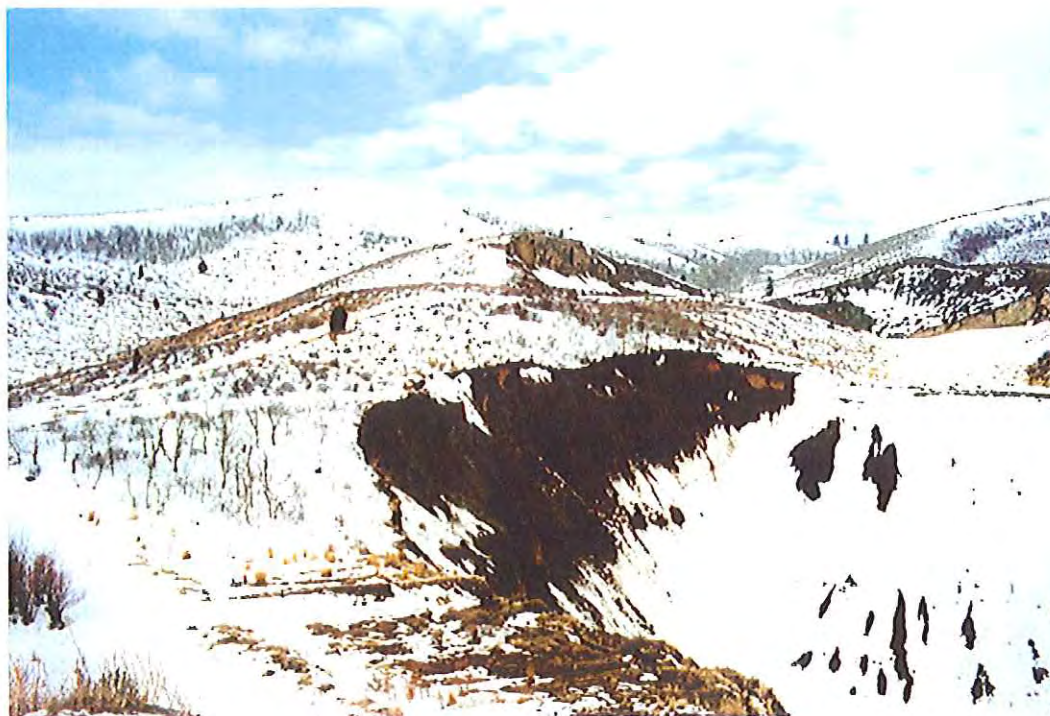
Photograph No. 3.5-2
Z Pit looking west to Y pits
3/2/00

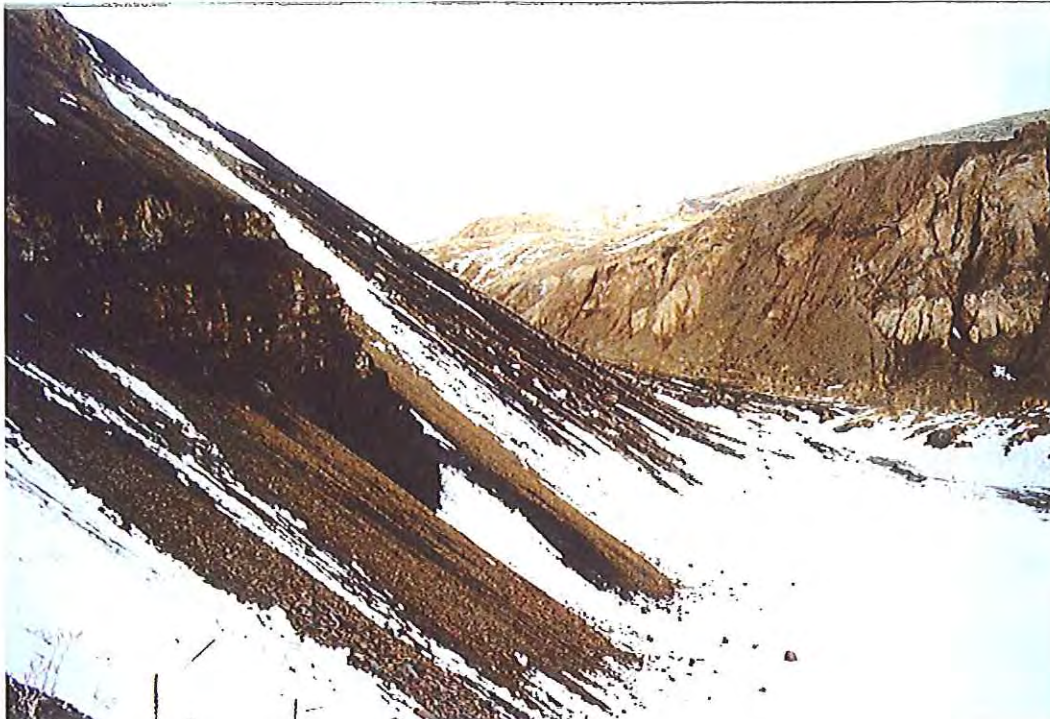
Photograph No. 3.5-5
Z Pit shows seam in west high wall
3/2/00

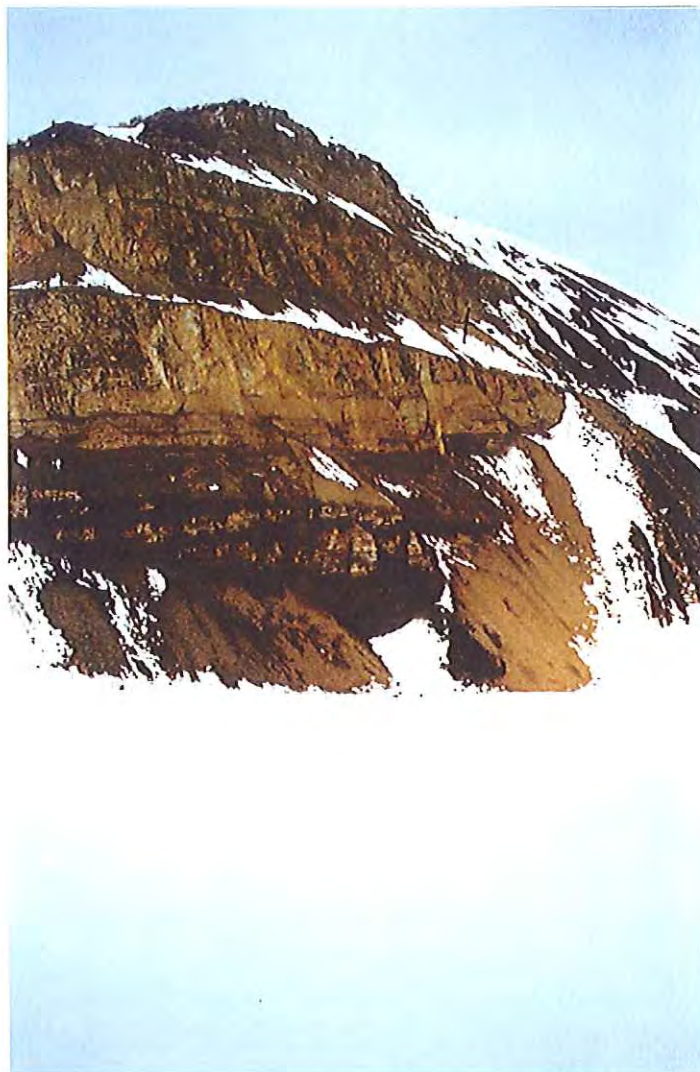
Photograph No. 3.5-8
Z Pit west wall showing chert above seam
3/2/00
